# Debris/Ice/TPS Assessment And Photographic Analysis For Shuttle Mission STS-38

Gregory N. Katnik  
NASA/Kennedy Space Center

February 1991

November 15, 1990

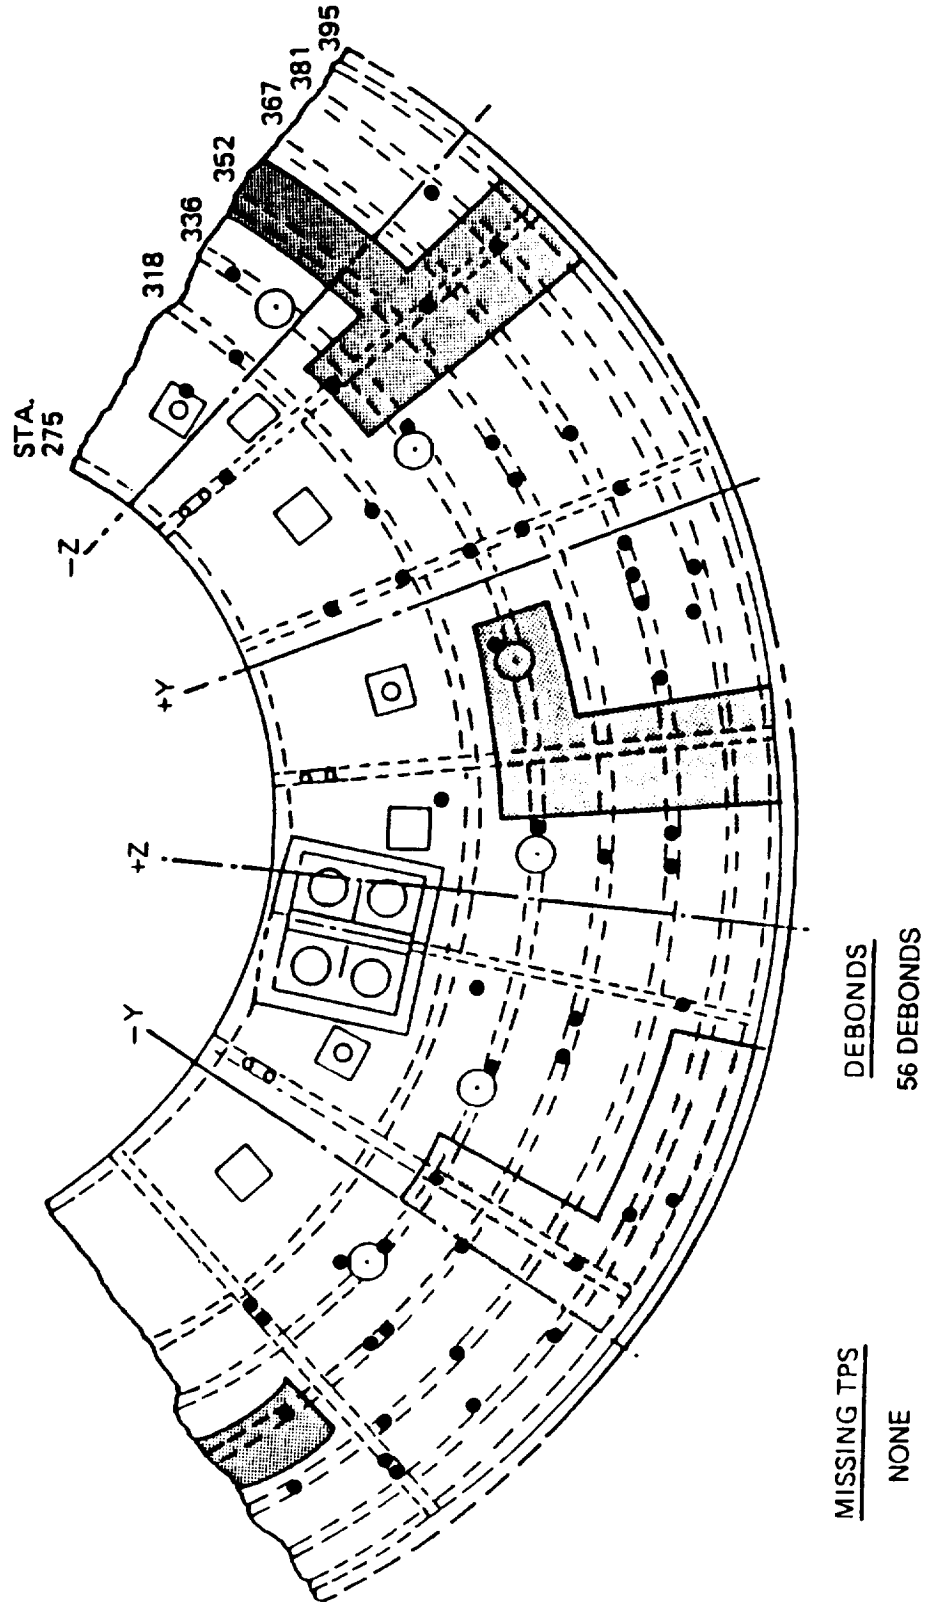
FIGURE 5. RIGHT SRB FRUSTUM

The nose cap was not recovered. The RH frustum had no areas of missing TPS but had 56 debonds over fasteners (Figure 5). The Hypalon paint was blistered slightly in localized areas. All BSM covers were fully opened and locked in the 180 degree position.

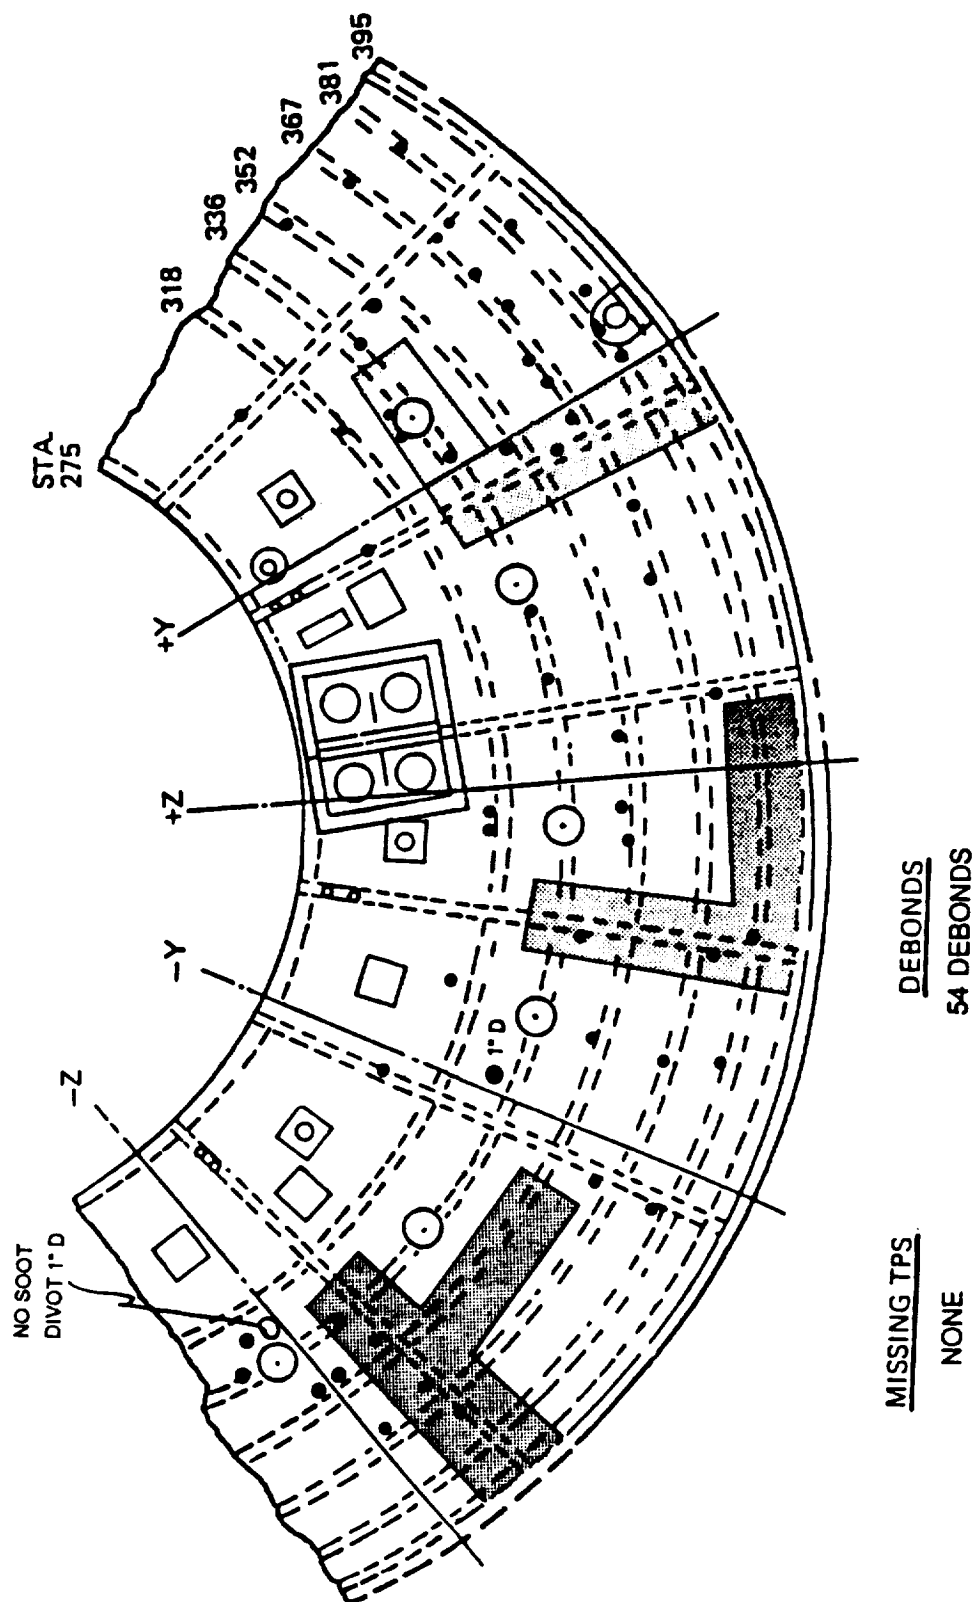
FIGURE 8. LEFT SRB FRUSTUM

The nose cap was not recovered. The LH frustum exhibited no missing TPS but had 54 debonds over fasteners (Figure 8). All of the BSM covers were fully opened and locked in the 180 degree position.

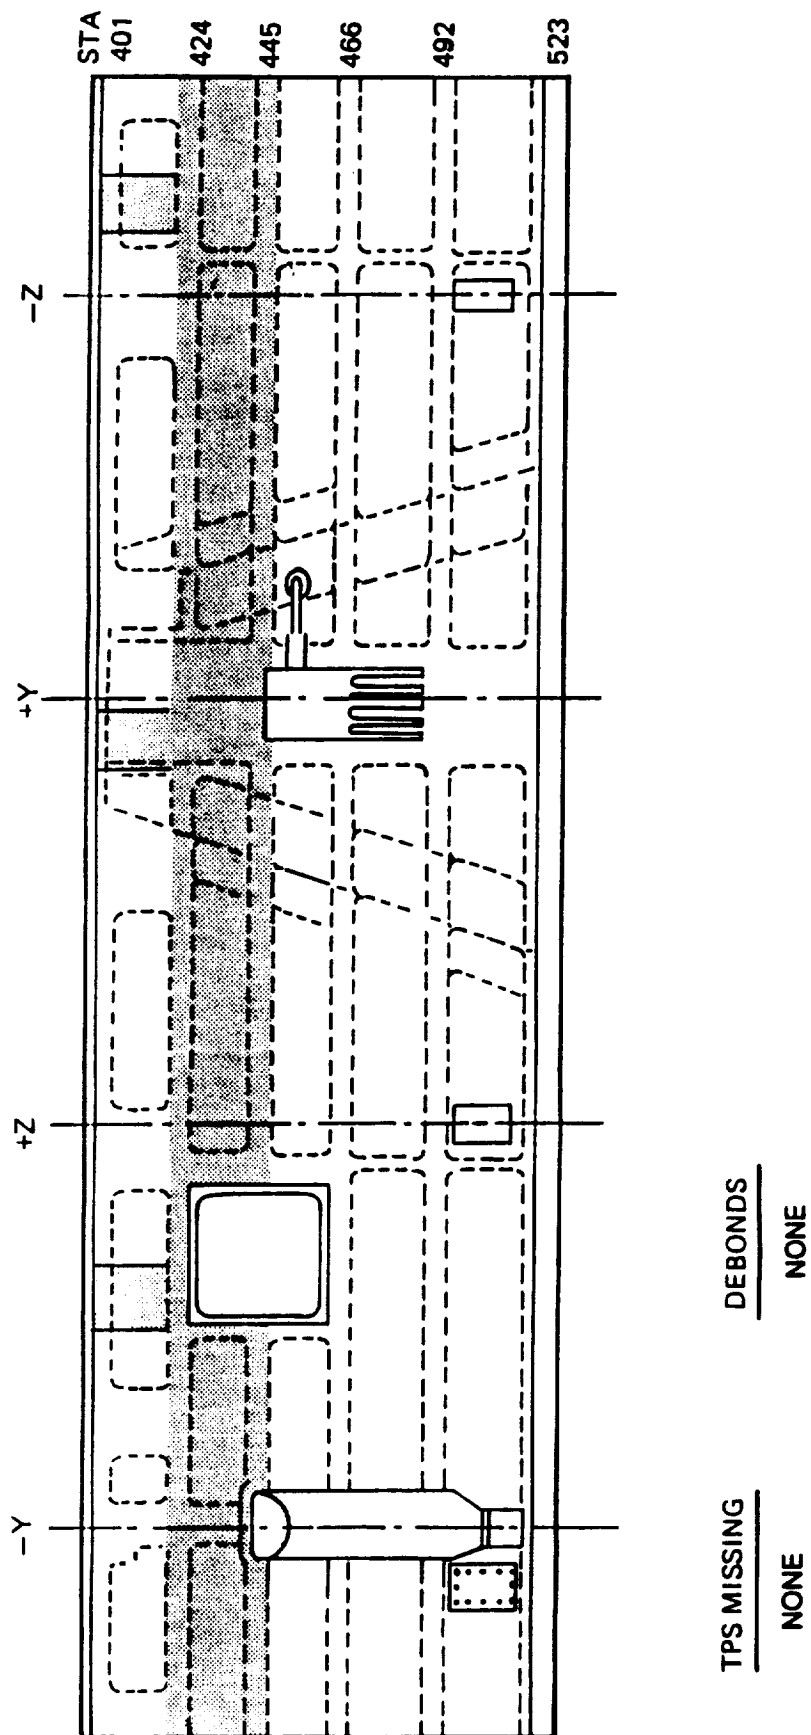
FIGURE 9. LEFT SRB FWD SKIRT

The LH forward skirt exhibited no debonds or missing TPS (Figure 9). Blistering of the Hypalon paint had occurred around the forward attach point. The frustum severance ring, utilizing the new pin retainer clips, was missing no pins. Separation of the forward attach bolt and electrical cables appeared normal.

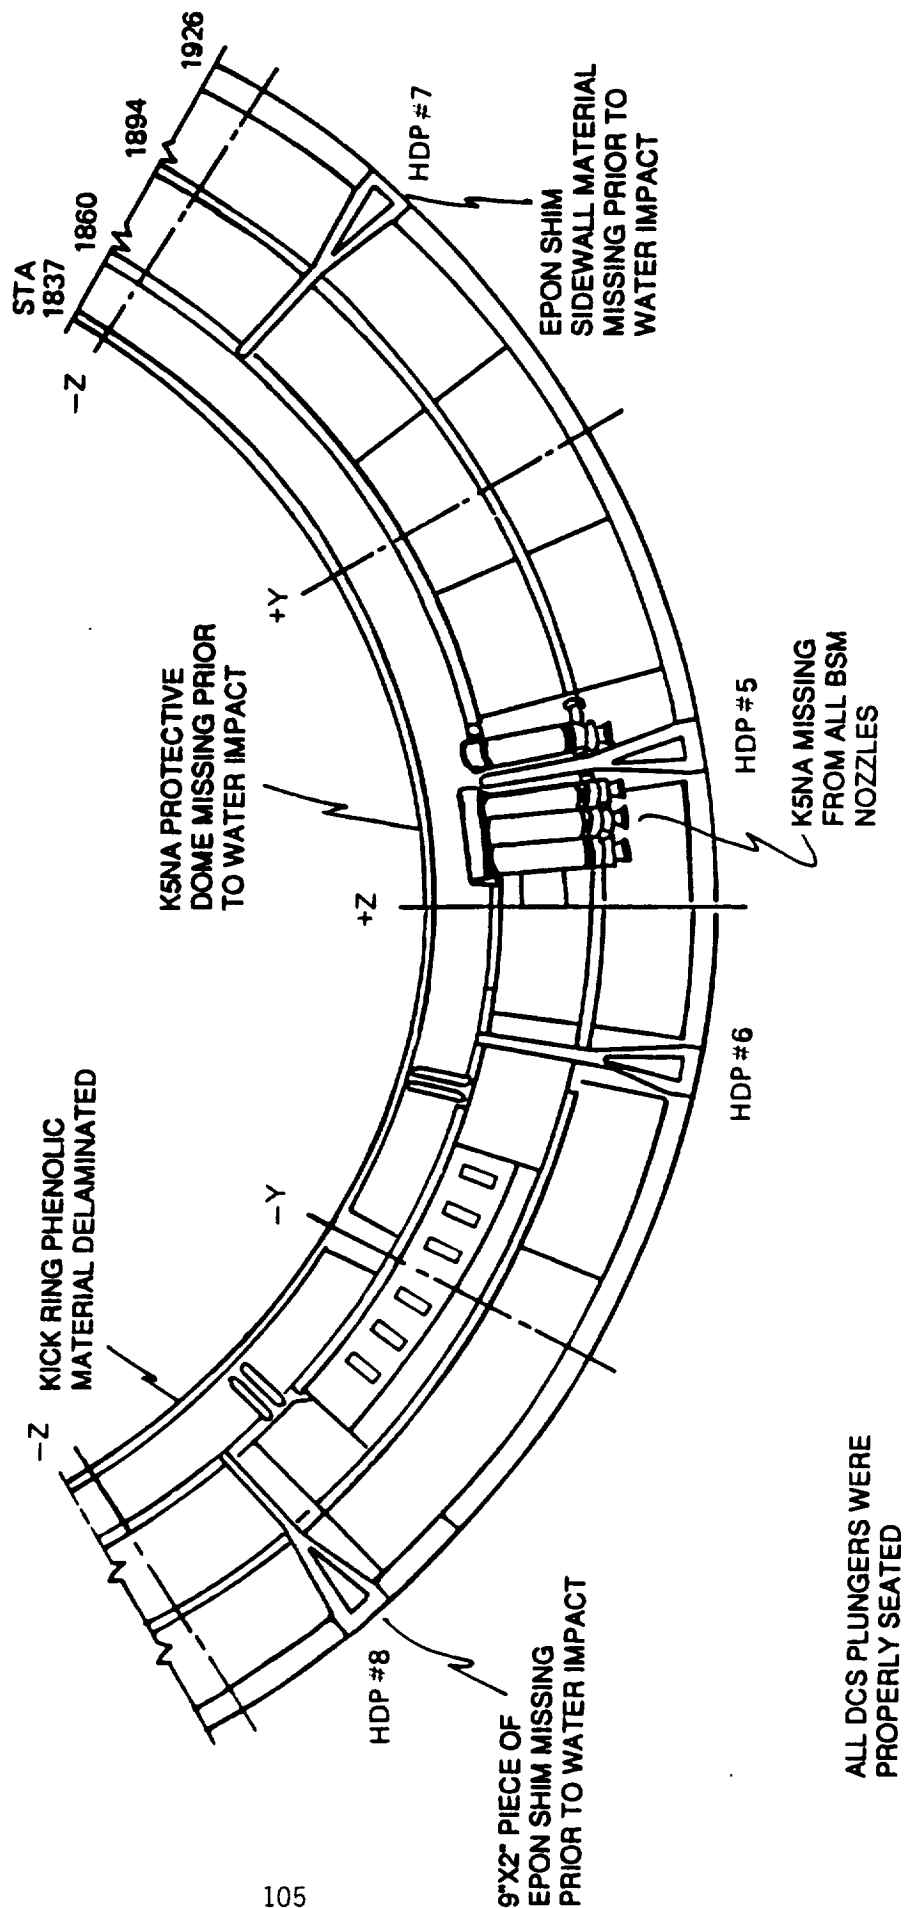
FIGURE 10. LEFT SRB AFT SKIRT EXTERIOR TPS

The TPS over the aft skirt acreage was generally in good condition (Figure 10). The phenolic material on the kick ring delaminated in several locations. K5NA was missing from all aft BSM nozzles. The TVC system appeared undamaged.

All DCS plungers were properly seated. Aft skirt HDP #7 was missing Epon shim from the inboard side of the foot and the substrate was sooted. A 9"x2" piece of HDP #8 aft face shim material was missing prior to water impact. The thermal curtain attach structure and aft skirt aft ring were inspected for damage caused by the suspected loss of a thermal curtain 34 seconds into flight, but no unusual damage was visible. Water impact may have altered any remaining evidence. Instafoam was missing from the aft ring around the aft skirt feet, HPU exhaust horns, and the SRB T-0 umbilical.

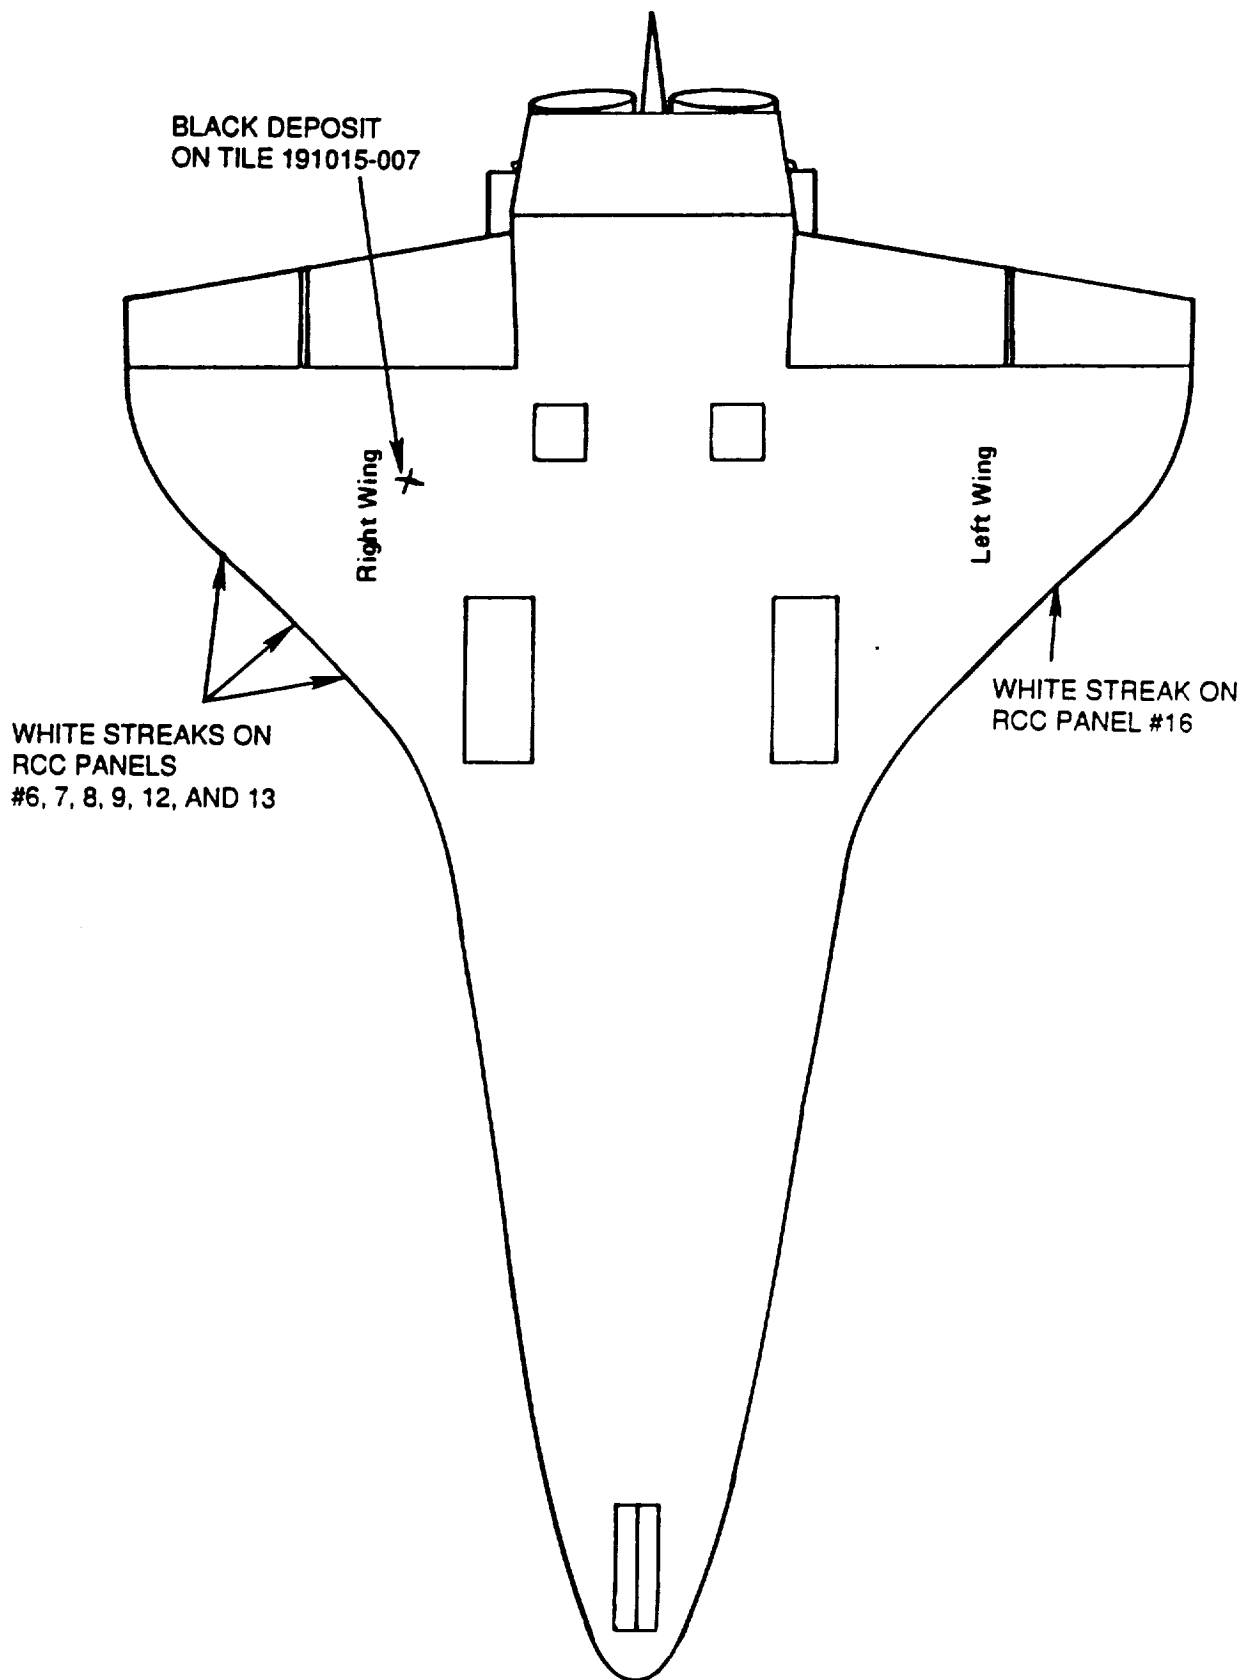
FIGURE 15. DEBRIS DAMAGE CHEMICAL SAMPLE LOCATIONS

After arrival in the OPF, samples were taken from the selected damage sites (Figure 15) for laboratory analysis. The results of all debris sample chemical analysis are presented in Section 10.0.

A total of 10 samples were obtained from Orbiter OV-104 during the STS-38 post landing debris assessment at Kennedy Space Center, Florida (Figure 15). The 10 submitted samples consisted of 7 wing leading edge RCC samples (6RH, 1LH), 1 tile residue sample, and reference samples: (1) foam "padding" used in wing leading edge RCC protective covers and (2) hypalon paint used in SRB processing. The samples were analyzed by the NASA KSC Microchemical Analysis Branch (MAB) for material composition and comparison to known STS materials. The specific elemental analysis is shown in the appended MAB report. Debris analysis involves the placing and correlating of particles with respect to composition, availability, and thermal (mission) effects. Debris samples and analyses are provided by Orbiter location in the following summaries.

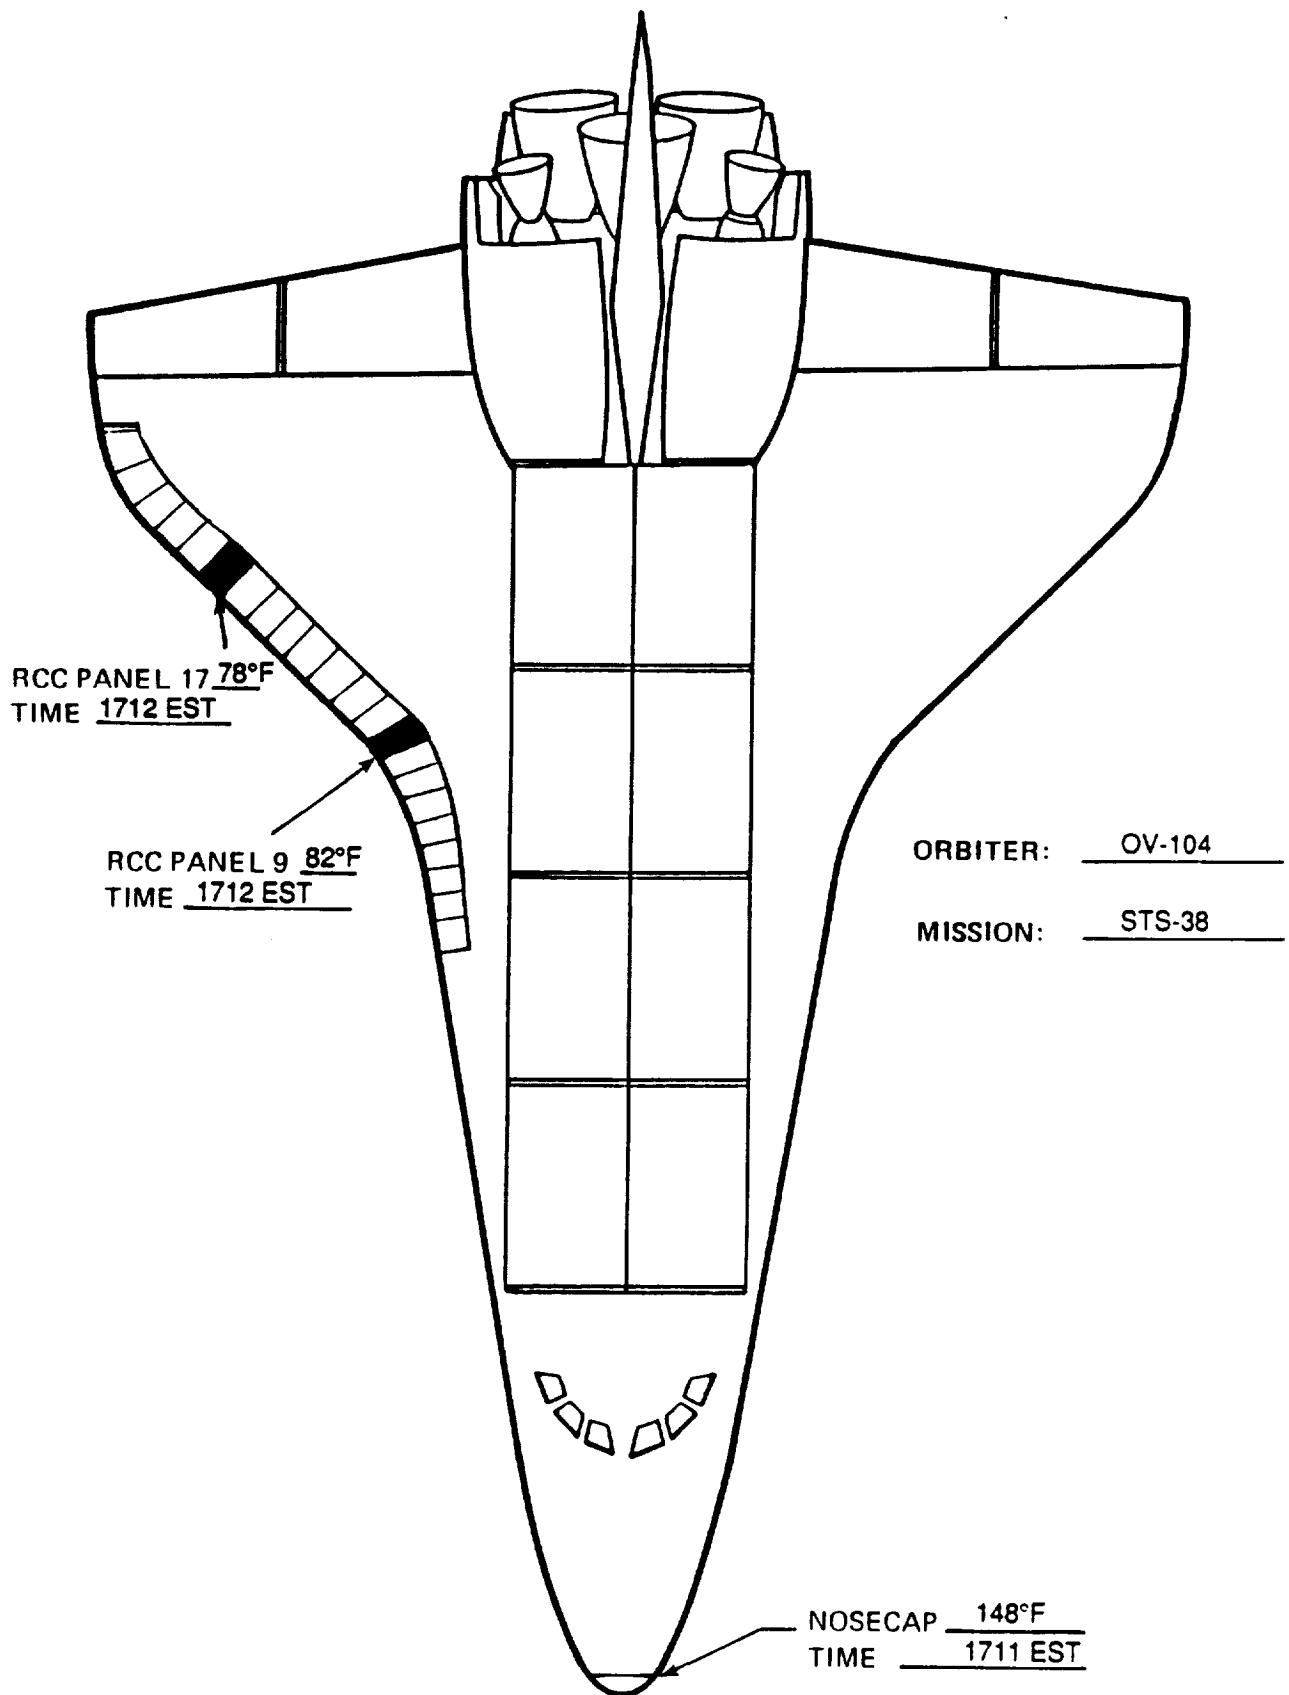
FIGURE 16. TEMPERATURE MEASUREMENTS

The KSC Shuttle Thermal Imager (STI) was used to record the surface temperatures of several areas (Figure 16). Twenty-eight minutes after landing, the nose cap RCC measured 148 degrees F. The RH wing RCC panel #9 and #17 measured 82 and 78 degrees F, respectively.

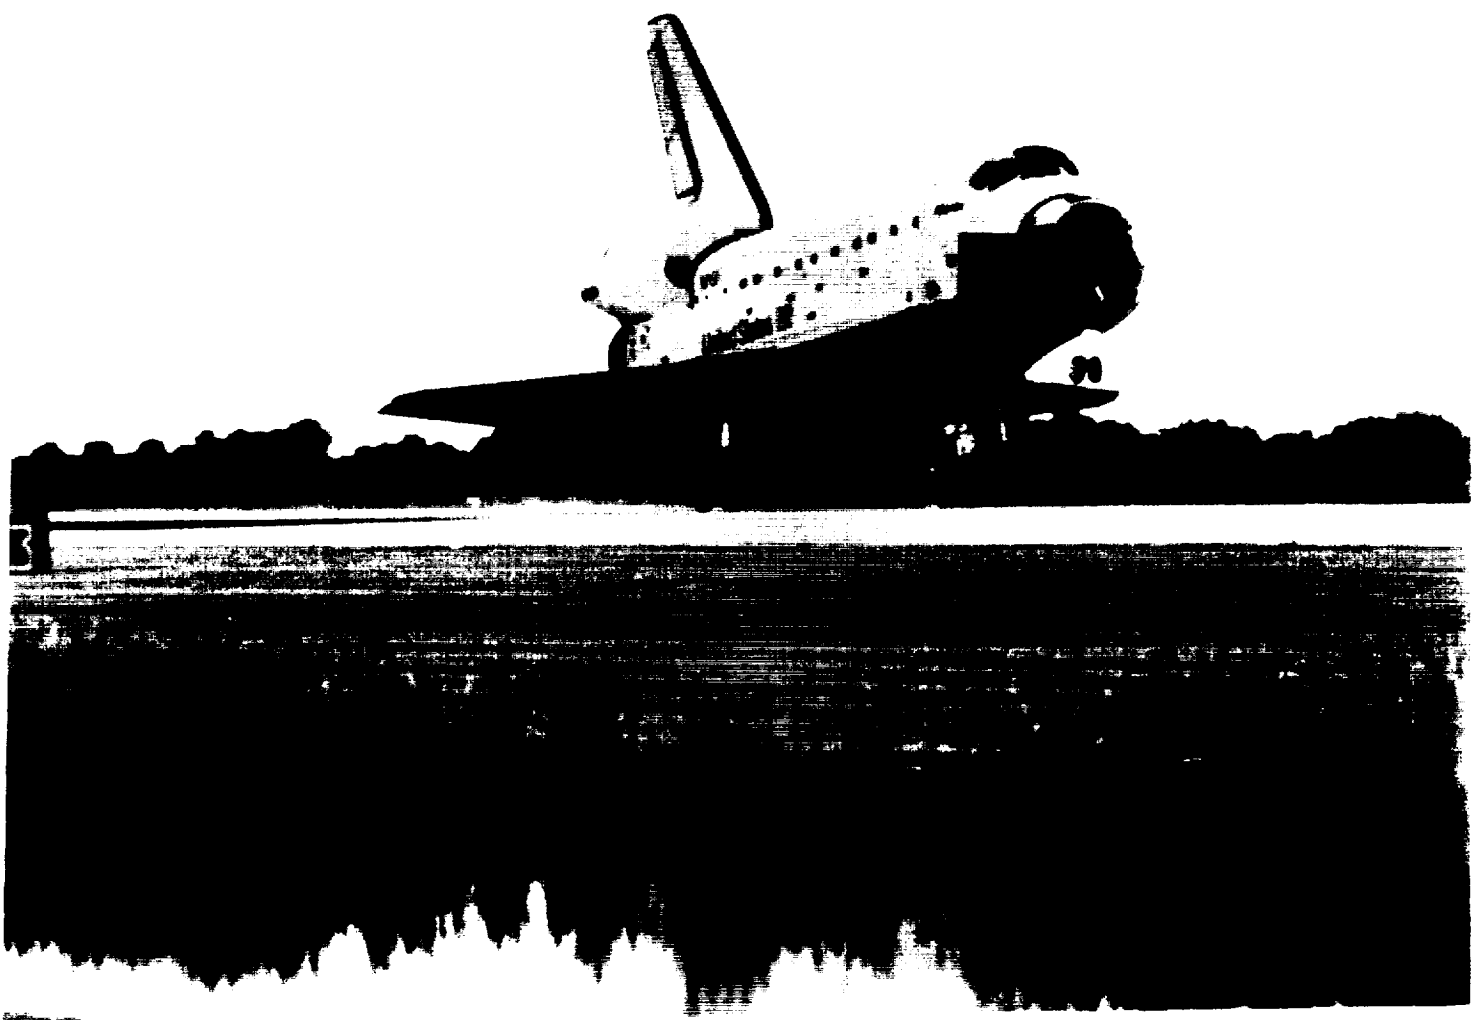
Two pieces of SSME closeout blanket, above the body flap near  
SSME #2 and outboard of SSME #3, fell aft during final approach

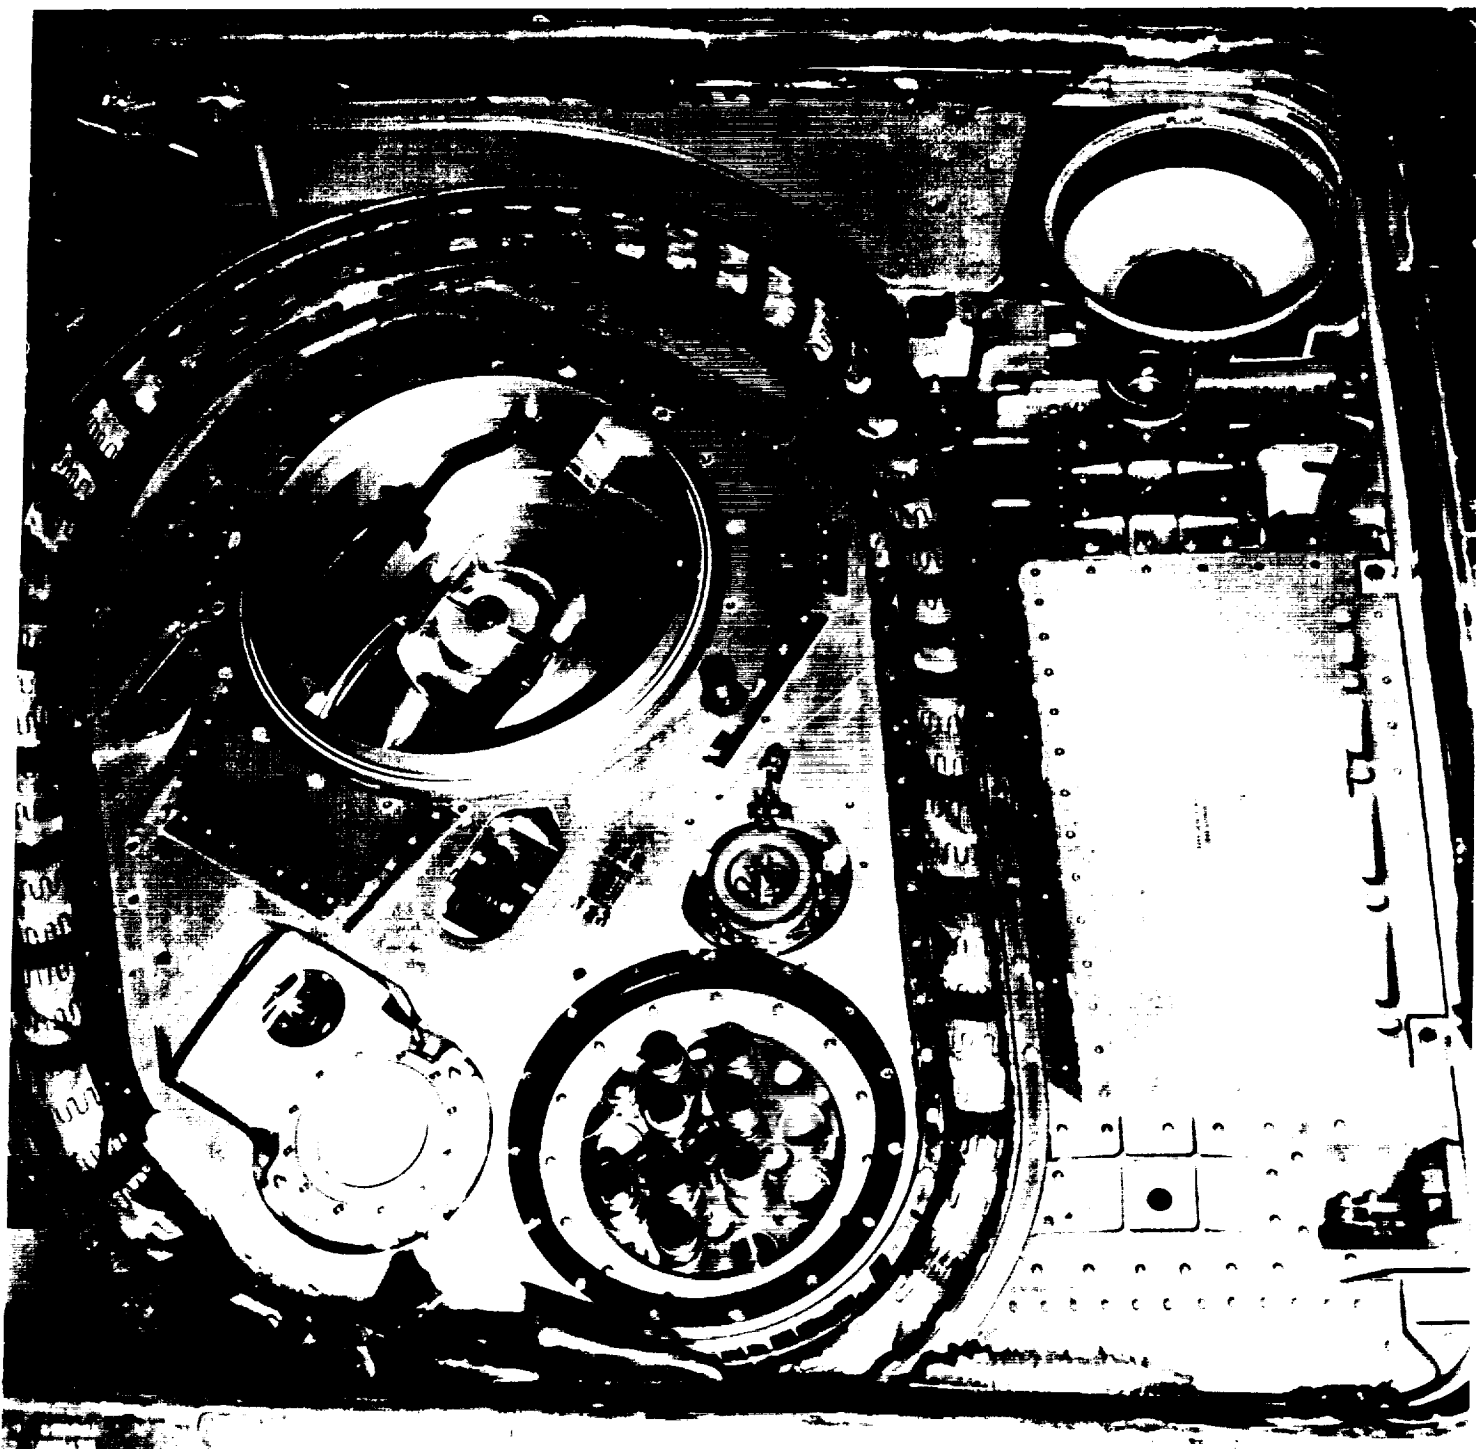
Post flight condition of the LH2 ET/ORB umbilical. The debris plunger in EO-2 was properly seated.

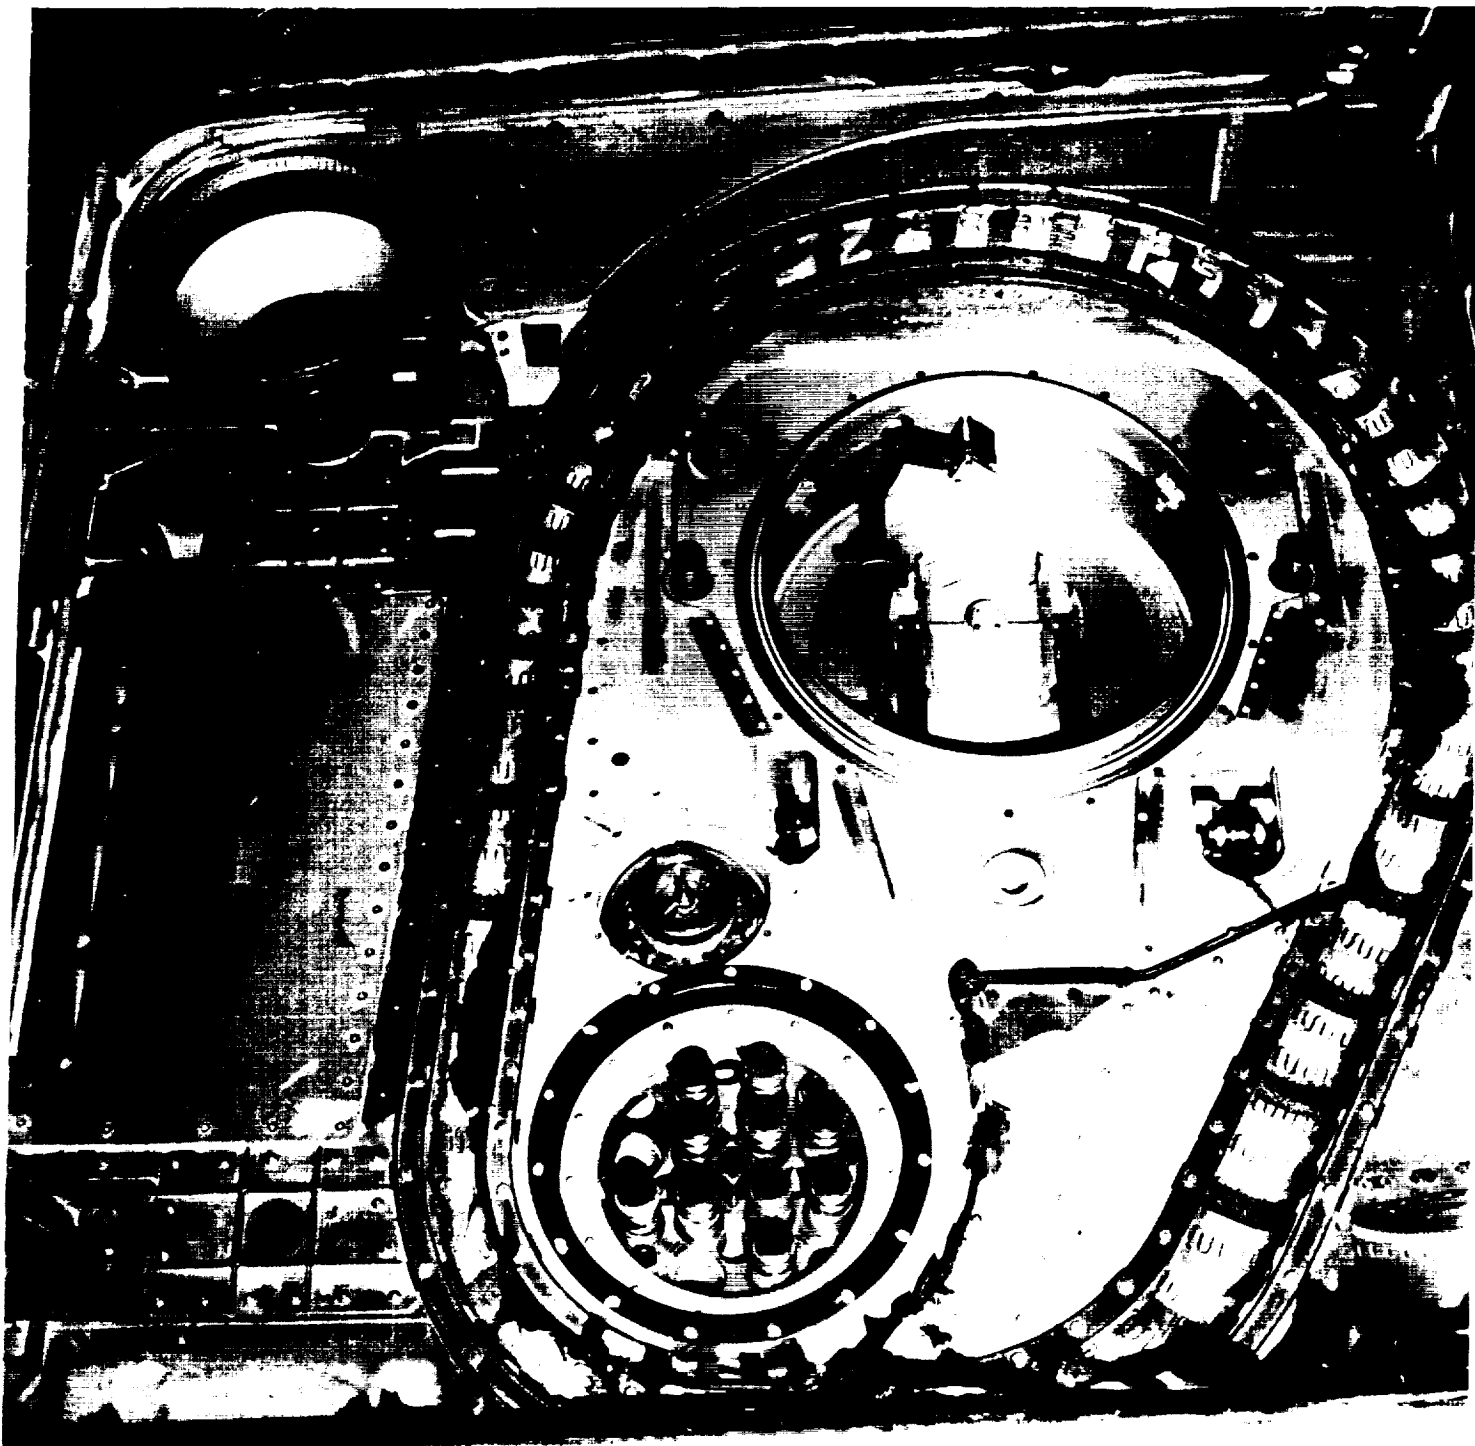
Post flight condition of the LO2 ET/ORB umbilical. The debris plunger in EO-3 was properly seated.
